AIRWORTHINESS DIRECTIVE

Number: CAA-AD-T-093/2003
Date of issue: December 01, 2003
ROBINSON HELICOPTER COMP.
R44, R44 II

HELICOPTER – MAIN AND TAIL ROTOR – SECURE BOLTS – INSPECTION/REPLACEMENT

2003-24-51 ROBINSON HELICOPTER COMPANY: Docket No. 2003-SW-48-AD.

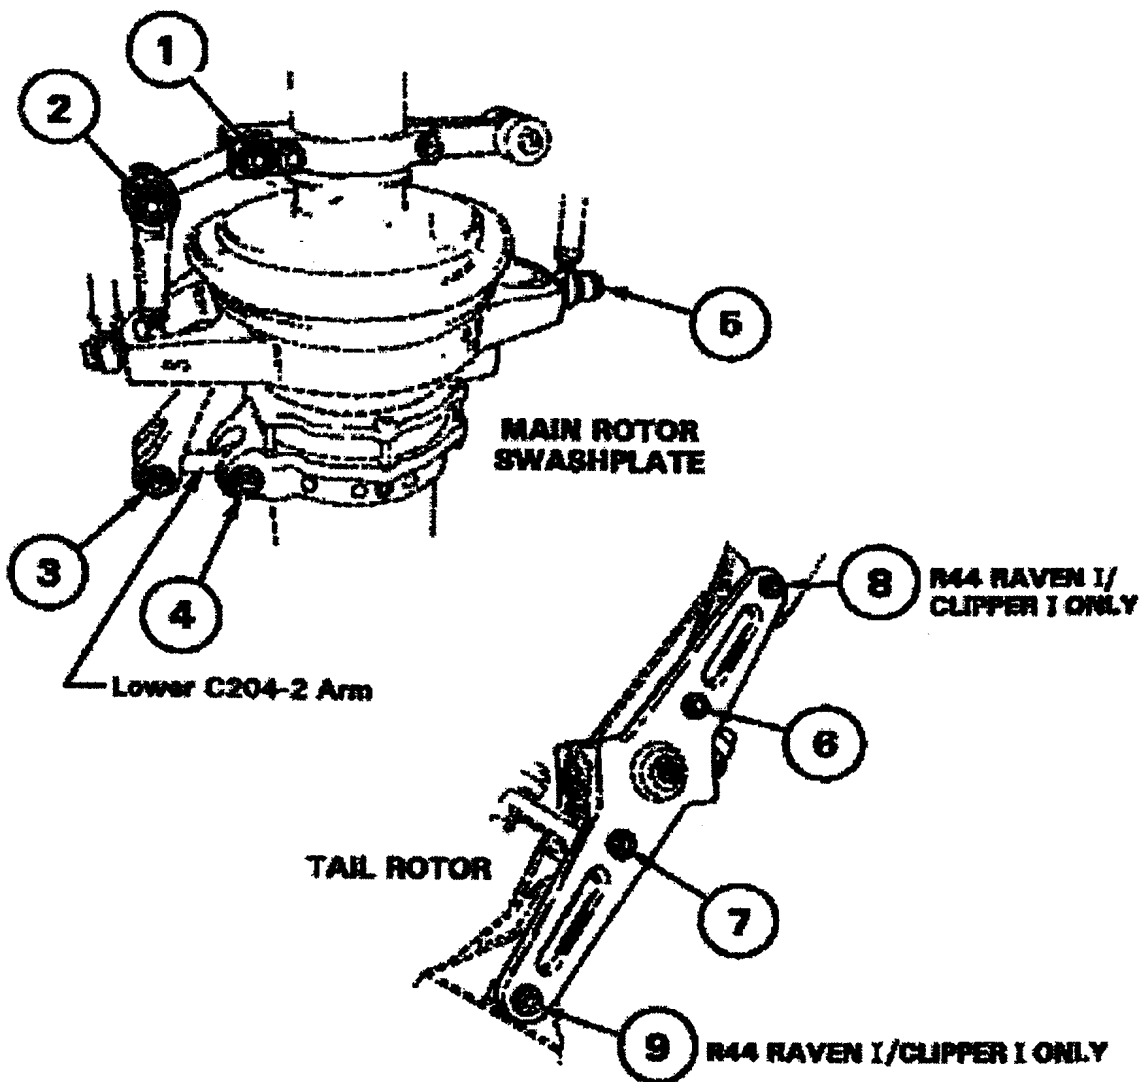
To prevent failure of the bolt that secures parts of the main rotor swashplate and attaches the tail rotor blade, and subsequent loss of control of the helicopter, accomplish the following:

(1) Visually inspect each bolt for fretting residue under the bolt head, which indicates a loose, potentially cracked bolt.

Suspect NAS6605-31 Bolts

9 Place on R44

7 Places on R44 II

(2) Apply 10-15 ft-lb (13-20 Nm) torque to each bolt head and verify no rotation. See Figure 1 of this AD.

(3) If residue or rotation of the bolt is found, before further flight, replace each unairworthy bolt with an airworthy bolt that does not have a vendor identification marking of 01DO.

- (e) For the helicopters specified in paragraphs (b) and (c) of this AD, within 10 hours time-in-service or by December 31, 2003, whichever occurs first, replace each bolt, P/N NAS6605-31, that has vendor identification marking 01DO on the bolt head, with an airworthy bolt, P/N NAS6605-31, that has an alternate vendor identification marking.
- (f) Bolt, P/N NAS6605-31, with vendor identification marking 01DO on the bolt head, is NOT ELIGIBLE for installation on any helicopter.
- (g) To request a different method of compliance or a different compliance time for this AD,
