AIRWORTHINESS DIRECTIVE

Number: CAA-AD-065/2003
Supersedes CAA-AD-T-115/2001
Date of issue: July 18, 2003
Schweizer Aircraft Corp.
269A, 269A-1, 269B, 269C, TH-55A

HELICOPTER – CLUSTER FITTING – INSPECTION/REPLACEMENT

2003-13-15 Schweizer Aircraft Corporation: Amendment 39-13217. Docket No. 2002-SW-25-AD. Supersedes AD 2001-25-52, Amendment 39-12726, Docket No. 2001-SW-58-AD.

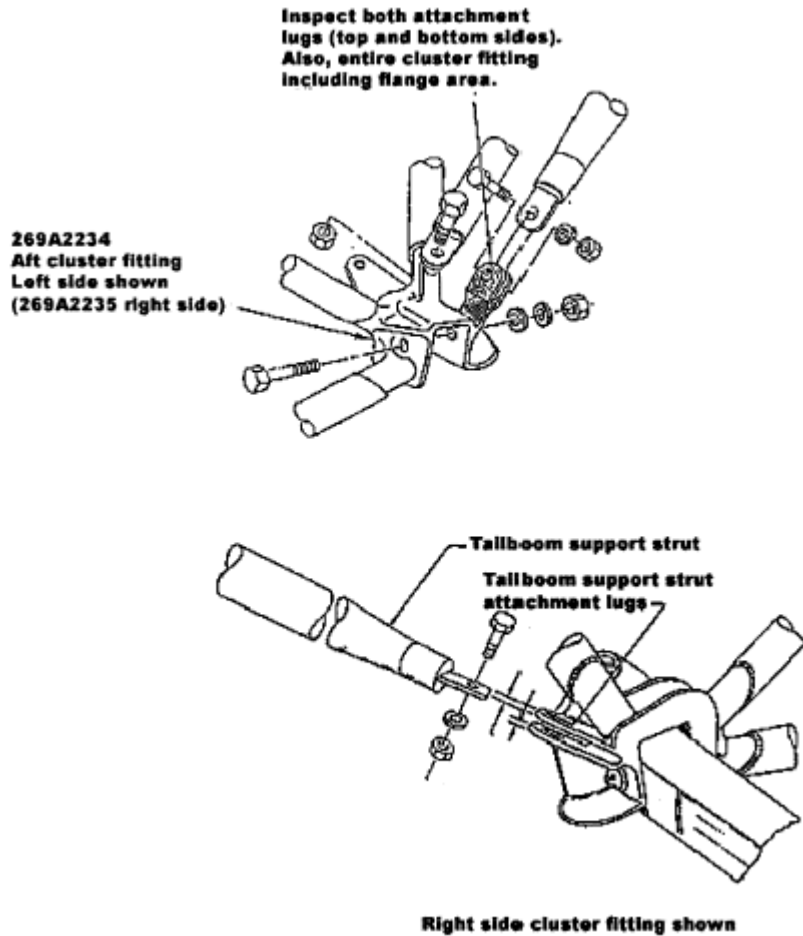
Figure 1

To prevent failure of a tailboom support strut or lug on a cluster fitting, which could cause rotation of a tailboom into the main rotor blades, and subsequent loss of control of the helicopter, accomplish the following:

(2) Dye-penetrant inspect the lugs on each cluster fitting. See the following Figure 1:

(3) If a crack is found, before further flight, replace the cracked cluster fitting with an airworthy cluster fitting.
